## Soil Anchors

# FACTSHEET

## SOIL ANCHORS

LUCINDA BEACH, NTH QLD

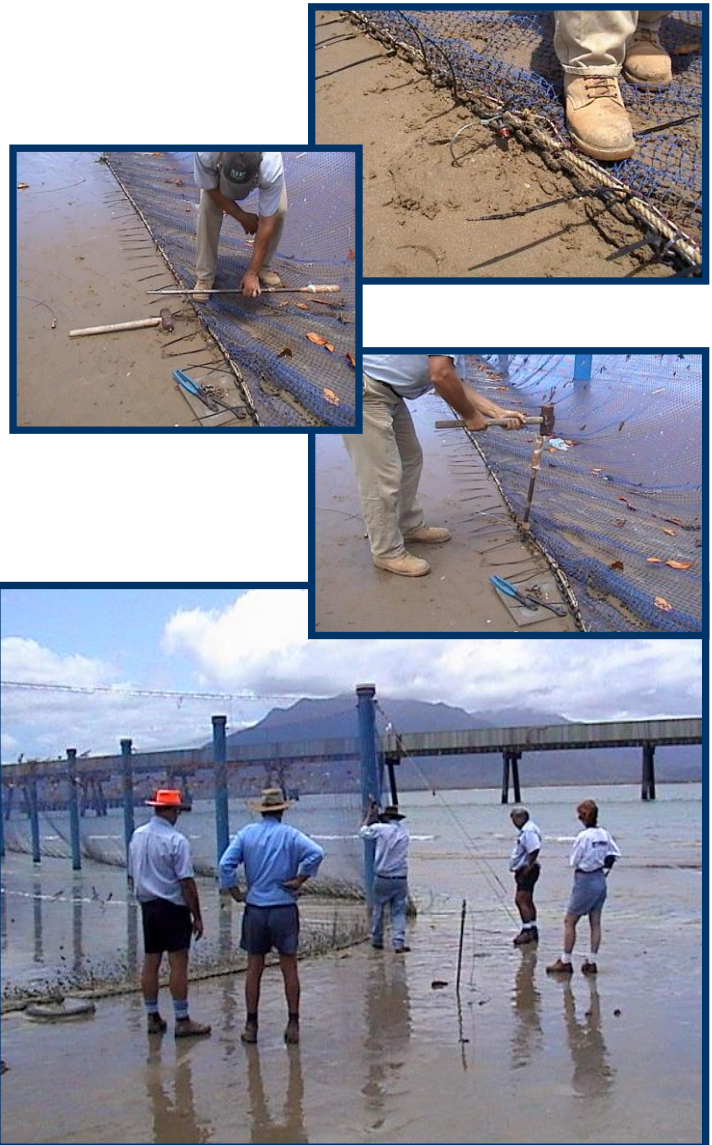
Groundwork Services crew showing Council workers how to install the anchors to netting. The anchor connected to the bottom of the netting, note that a "D"-shackle has been used to connect the hard eye of the anchor tendon to a link in the chain at the bottom of the netting. Anchor tail with hard eye ready for connection to the netting after the anchor has been driven and load locked. Driving the anchor with a sledge hammer.

Groundwork Services staff advised that the combined effort of three Council workers could not budge an S06EA anchor driven 800mm into the ground.
